NSD Clutch Springs

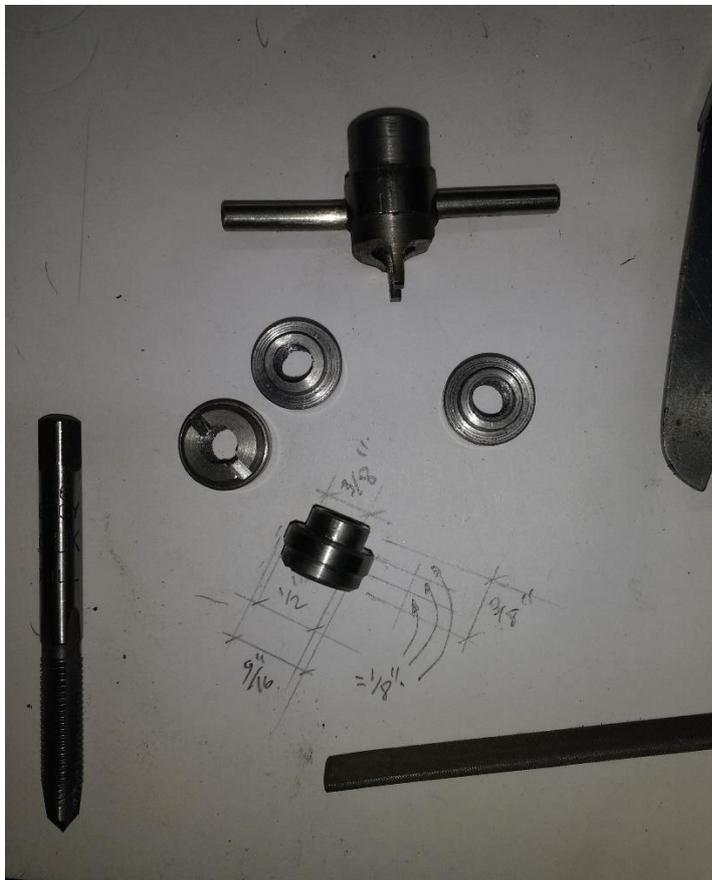
Although the clutch was in good order, the spring compressing nuts had gone missing at some time and had been replaced by $\frac{1}{4}$ " nuts and washers which are difficult to assemble (need to compress each spring before the nut can be engaged). The detail doesn't show in my fizzy parts list illustration, so I made up some nuts similar to those I've seen on other bikes.

Starting with $\frac{9}{16}$ " diameter silver steel bar that I picked up at an autojumble for £1, I machined up these nuts, each $\frac{3}{8}$ " long with $\frac{1}{8}$ " sections $\frac{3}{8}$ " diameter (to fit the springs' ID), $\frac{1}{2}$ " dia., and $\frac{9}{16}$ " dia. A little chamfer on the outside and hand cut slots using hacksaw and needle file. While I was at it, I made up a little tool (top of picture) to engage in the slots and drive the nuts.
